(NASA-CR-167962) JT90 CERAMIC OUTER ALU SEAL SYSTEM REFINEMENT PROGRAM, PHASE 2 (Pratt and Whitney Aircraft Group) 48 p HC A03/MP A01 CSCL 21E N83-15305

# JT9D Ceramic Outer Air Seal System Refinement Program-Phase II

UNITED TECHNOLOGIES CORPORATION PRATT & WHITNEY AIRCRAFT GROUP COMMERCIAL ENGINEERING

NATIONAL AERONAUTICS AND SPACE ADMINISTRATION
Lewis Research Center
Contract NAS3-20630

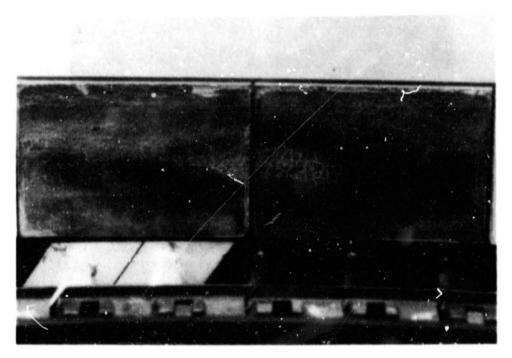
Forty eight (48) sprayed ceramic seal segments were installed. Figure 7 shows a typical turbine module assembly. Thirty (30) of the 48 seal segments were of the proposed design and formed the lower half of the seal stage where a blade seal rub was anticipated. Figure 8 shows a closeup of three of these segments installed in the turbine case. The upper half of the seal stage was composed of 18 segments of an earlier design. Figure 9 shows typical pre-test conditions of two of the 18 segments as installed in the case.

Figure 9 Two of Eighteen Sprayed Ceramic Seal Segments of an Earlier Design with Previous Engine Test Time

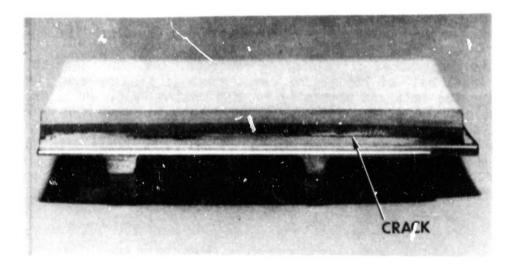
After assembly the seals were ground in the case, Figure 10, to provide desired blade/seal clearance, and subsequently disassembled for cleaning and inspection. Two segments of the JT9D design were observed to have laminar cracks as shown in Figure 11 and were replaced. Experimentation with spare seal segments produced similar cracks indicating the reason to be mechanical loading resulting from assembly and not a basic deficiency in the system.

Figure 11 Laminar Cracks Occurred During Assembly

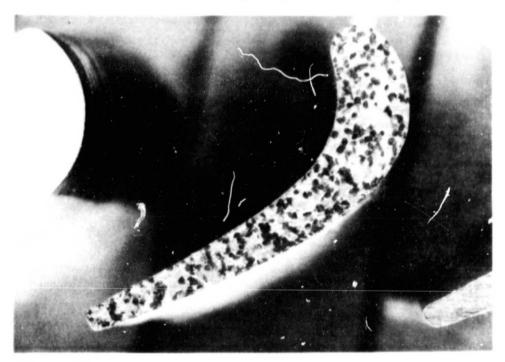
Figure 12 Typical Pre-Test Condition of the Abrasive Tip

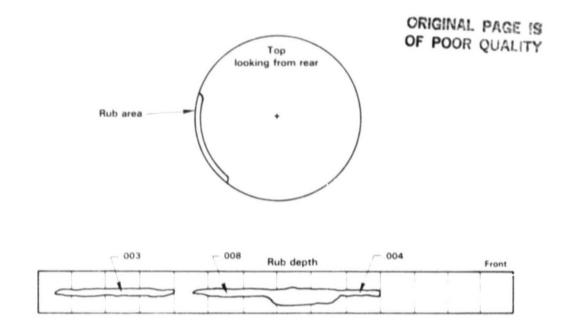
Ten of the seals were rubbed by the blades to a maximum rub depth of 0.020 cm (0.008 in). A sketch of the rub path and location is shown in Figure 15. Figures 16 and 17 are photographs of the rub path showing a clean groove with no metal transfer from the blades. Inspection of the seals in the turbine module revealed that only eight (8) seal segments had minor laminar cracks at the leading edge and only one (1) was visible without magnification. Inspection of the blades, limited because of the lack of disassembly, indicated little, if any, smearing or wear of the blade tips.

Figure 15 Ten Ceramic Seal Segments were Rubbed up to a Depth of 0.02 cm (0.008 in)

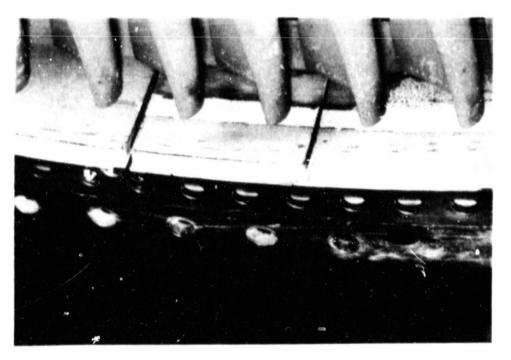
Figure 16 Photograph of Rub Path Showing Clean Groove with No Metal Transfer from the Blades

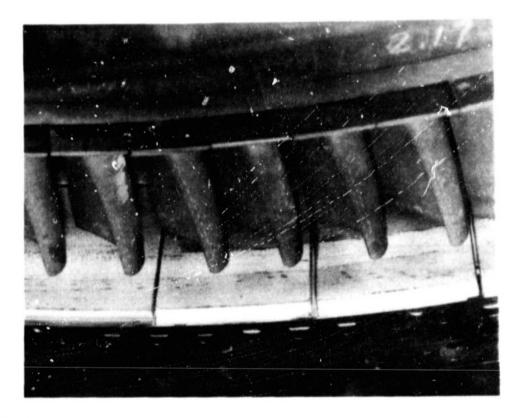
Figure 17 Photograph of Rub Path Showing Clean Groove with No Metal Transfer from the Blades

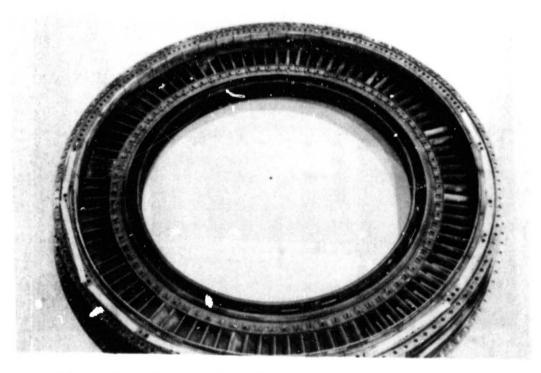
Figure 19 shows the turbine assembly removed from the engine. All proposed design seal segments were intact and in good condition. Only five (5) segments showed minor spalling and location of material removed was generally outside the blade path location thereby not contributing to performance deterioration. The generally good structural appearance of the seals is shown in Figure 20. The largest spall in the blade path location is shown in Figure 21. This spall is at the location of a radial step with the seal edge being closest to the blade diameter. Blade movement was from right to left in Figure 21 and it is expected that blade contact on that edge of the seal may have contributed to that spall. Inspection also revealed radial and laminar micro-cracks but little evidence of connection between the two types of cracks that would contribute to material spalling.

Figure 19 Turbine Assembly Removed from the Engine

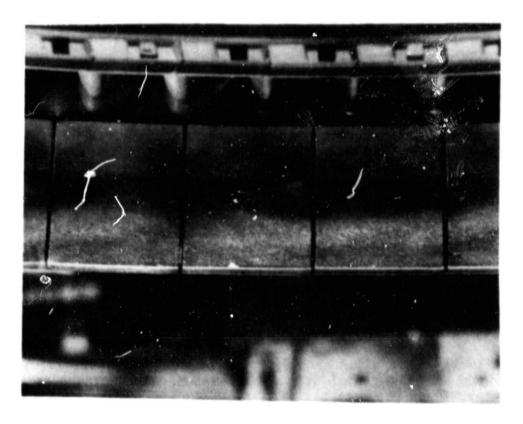
Figure 20 Sprayed Ceramic Seals Successfully Completed FAA Type Cyclic Endurance Test Without Adverse Effects

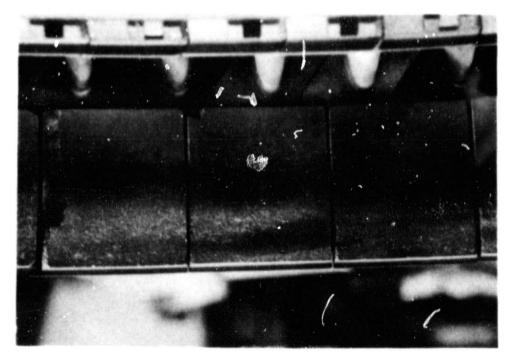
Figure 21 The Largest of Five Spalls

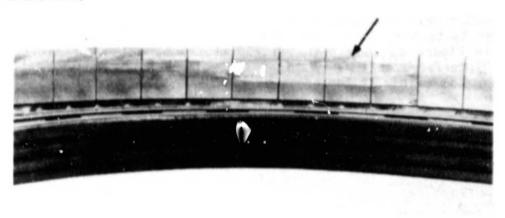
An additional rub, shown completely in Figure 22 resulted during the endurance program. It is expected that this rub was generated by slow thermal growth interaction and by excessive unbalance. As shown in Figure 23, this rub was in essentially the same location as the earlier rub generated during the acceleration transient.

Figure 22 Additional Rub Resulting During the Endurance Program

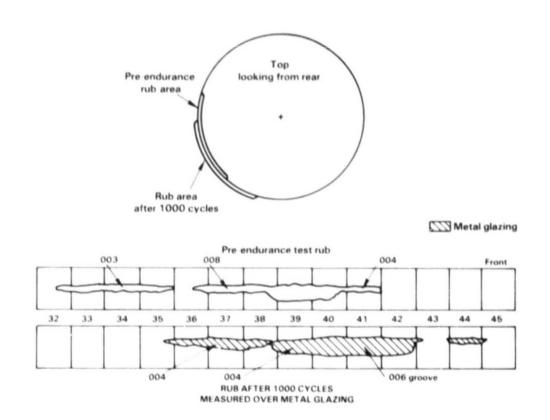
Figure 23 Rub During Endurance Testing is in the Same Location but Produced Glazing

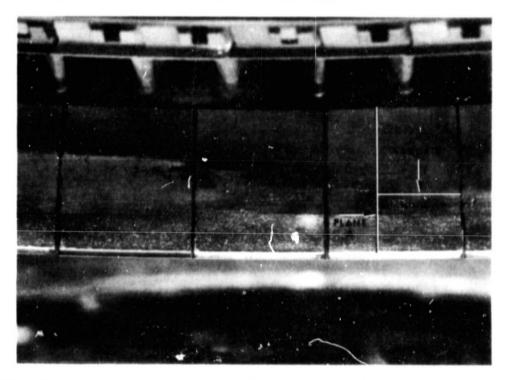
Metallographic inspection of one of the seal segments was sectioned to investigate the thickness of blade material deposited on the seal and the nature and relationship of radial and laminar cracks. Figure 24 is a closeup photograph of the seal sectioned and shows the cuts made and the seal planes inspected metallographically. Figure 25 is a picture of plane A and shows the rub path. Blade material transfer in this location was similar in appearance to that on other seal segments. Metallographic examination, Figure 25, showed this transfer to be very thin, less than 0.005 cm (0.002 in). Examination of the cracks in Figure 26 show that the radial cracks extend primarily to the 85/15 layer interface. Very few laminar cracks were observed indicating that this occurrence is mainly at the edges of the segment.

Figure 24 Closeup Photograph of Seal Sectioned Showing Metallographic Inspection Locations

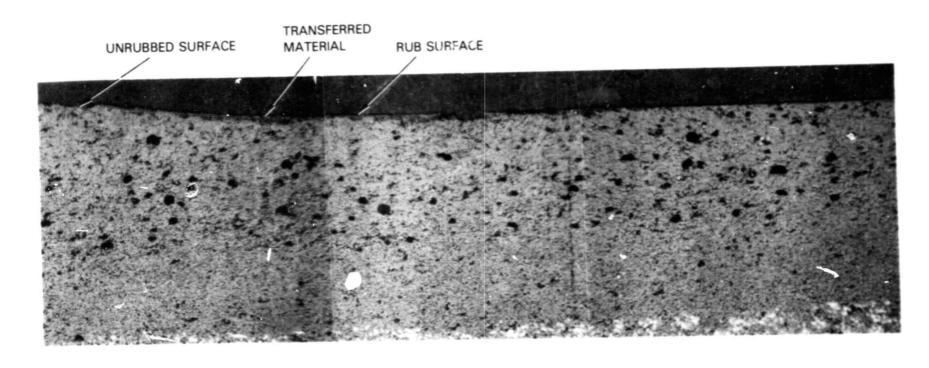
Figure 25 Plane A of Figure 24 Showing Rub Path and Thinness of Transferred Material

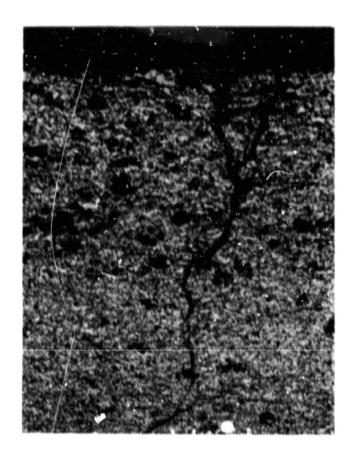
Figure 26 Metallography of Plane B of Figure 24 Showing Radial Cracks Extend to the 85/15 Layer

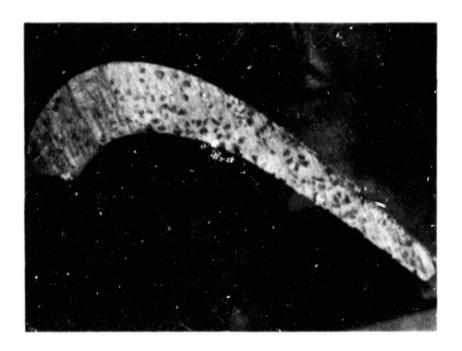
Inspection and measurement of the 27 abrosive tip blades revealed that all had worn an average of 0.043 cm (0.017 in). Inspection of non-tip treated blades which were machined shorter than the abrasive tip blades substantiated that wear, in that some of them had also worn slightly. A photograph of a typical abrasive tip blade after engine test is shown in Figure 27. Metallography shown in Figure 28 shows good structural integrity but the efficiency of the abrasive tip was lost because the smearing metal matrix filled the cavities between the grits.

Figure 27 Photograph of Typical Abrasive Tip Blade After Engine Test

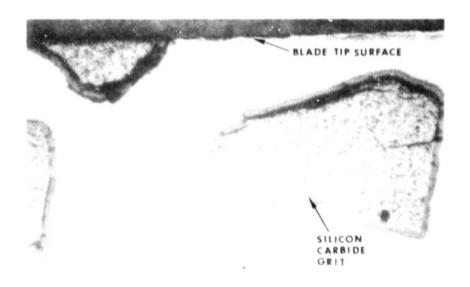
Figure 28 Metallography Showing Good Structural Integrity of the Abrasive Tip

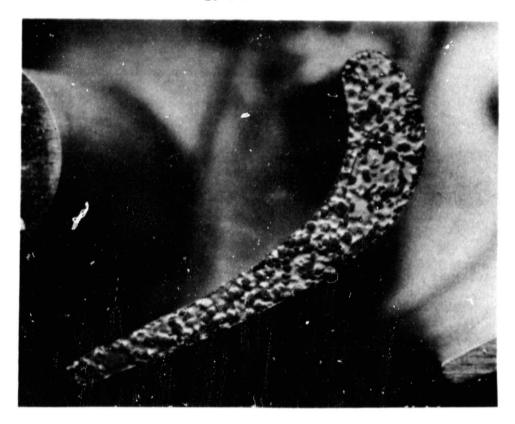
Figure 30 Typical Blade Tip

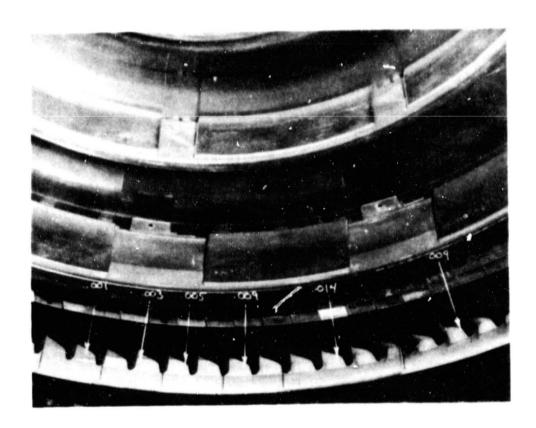
The turbine assembly was removed from the engine and the blades and seals inspected in the assembly. Nine (9) of the seals were rubbed to a maximum depth of 0.036 cm (0.014 in) as shown in Figure 33. The rub path was clean with no evidence of blade material transfer. Inspection revealed that blade tips were generally unaffected with grits still exposed. Although inspection of the blade tips in the assembly was difficult, by using a mirror it was determined that only 16 of the 34 blades had interacted with the ceramic seals. Based on the assumption that those 16 blades had worn an average of 0.0013 cm (0.0005 in), a volume wear ratio of 225 was calculated which is significantly greater than the design goal of 10.

Figure 33 Nine Ceramic Seal Segments Were Rubbed to a Maximum Depth of 0.036 cm (0.014 in)

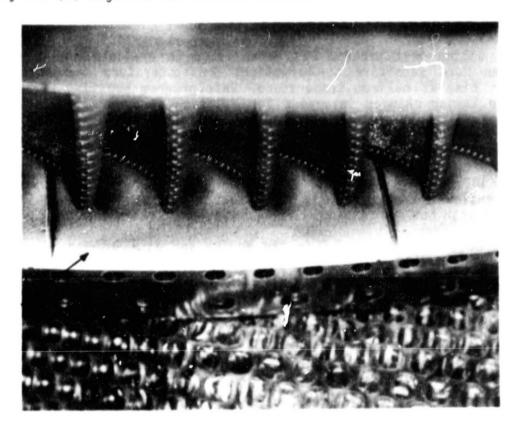
The seals were further inspected and were found to have radial cracks to varying degrees, the most noticeable of which can be seen on the segment shown in Figure 34. Inspection of the leading edge of each of the segments revealed that only two (2) segments had laminar cracks.

Figure 34 Seal Segment with Most Noticeable of the Radial Cracks

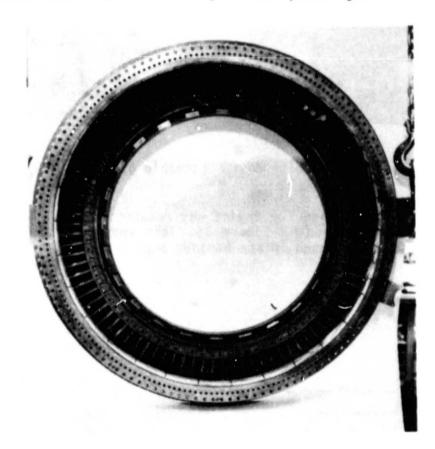
The turbine module was removed from the engine and disassembled. The seal assembly is shown in Figure 36 and reveals, by the second vane burn-through in the two o'clock location, the severity of the operating conditions.

Figure 36 Seal Assembly Revealing Severity of the Test Program

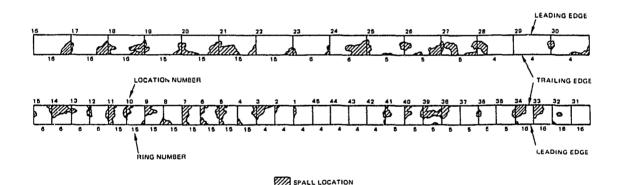
The seal segments were removed from the module and inspected. Seal spalls were documented by sketching each of the seals as shown in Figure 37. Spalling of the seal area immediately under the blade path was surveyed and measured to determine the effect of the engine operating conditions on performance degradation. It was determined that only 20 percent of the seal surface area under the blade path was spalled. A closeup of one of the locations is shown in Figure 38. Although certainly not desirable, estimates indicate that the spalling was approximately equivalent to only 0.025 cm (0.010 in) in clearance increase. The significance of the decrease in engine performance associated with that 0.025 cm (0.010 in) clearance increase is reduced when considering the relative condition of other engine components such as the combustor, vanes and blades. In addition, the ceramic thickness of the seal segments tested in this engine was less than the design objective. Less ceramic means less insulation and therefore a higher temperature at the first intermediate layer (85/15). It is reasonable to assume that greater oxidation of the CoCrAlY in this layer occurred and, as a result, strains, greater than expected in the design configuration, contributed to the spalled conditions.

Figure 37 JT9D Sprayed Ceramic Seal Segments Spall Locations After 1825 Extreme Engine Cycles

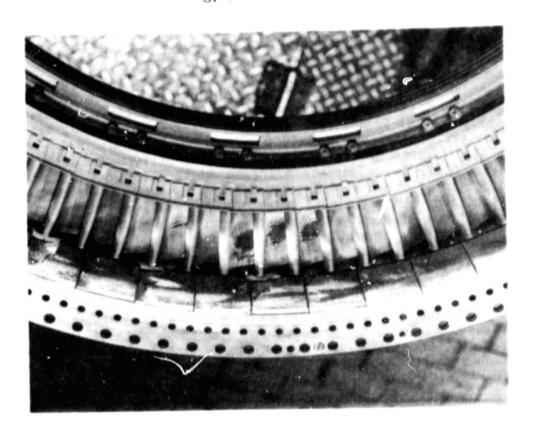
Figure 38 Closeup of One of the Spalled Locations

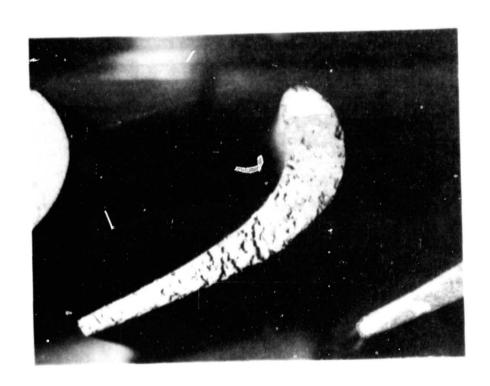
Inspection of the blades revealed typical conditions associated with time at high temperature. Blade tips, those tipped and those without revealed oxidation and cracking. Generally, the tipped blades showed more radial cracks but less oxidation attack. A picture of a typical abrasive tipped blade after the test is shown in Figure 39.

Figure 39 Picture of Typical Abrasive Tipped Blade After Test
